# Building Inspection Report

**123 Easy St Greenville SC**

**Inspection Date:**  
11/11/11

**Prepared By:**  
**Absolute Inspection Service LLC**  
6670 New Cut Rd  
Inman SC 29349

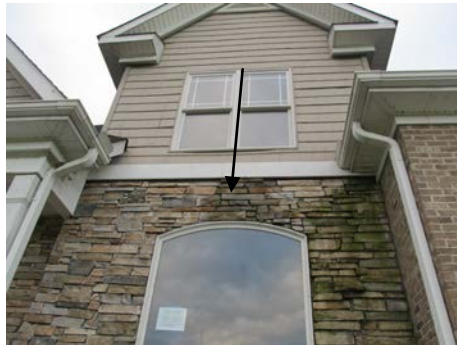
There appeared to be some structural movement at the front middle stone area.

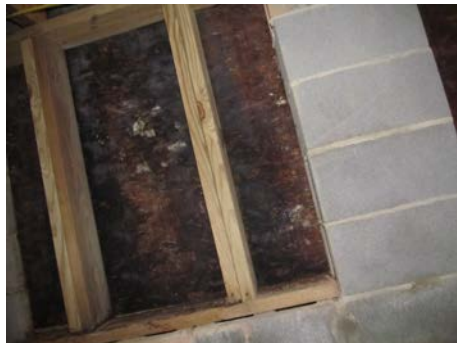
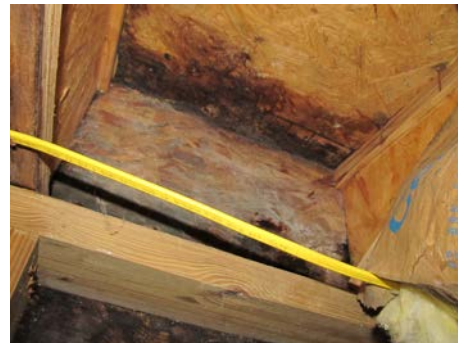
Water has damaged the floor framing and osb board under the front stone work. There appeared to be a mold like substance there. There could be hidden damage in the wall there. Recommend further evaluation and repair by a licensed contractor.

Water has damaged the floor framing and osb board under the front stone work. There appeared to be a mold like substance there. Recommend further evaluation and repair by a licensed contractor.

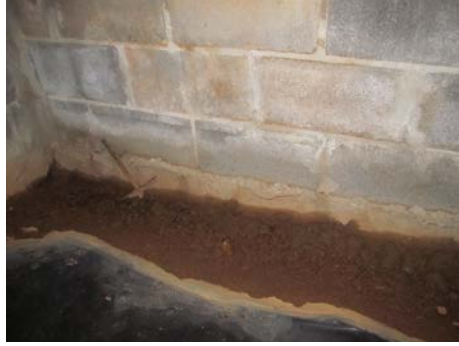
- **Repair:** Standing water was observed in the crawl space. Wet crawl spaces risk building damage from rot and insects and can cause interior mold or mildew. Roof and lot drainage repairs or improvements should be addressed as a first step to controlling water in the crawl space (see “Exterior”). This condition should then be monitored to determine if additional, potentially costly measures are necessary.

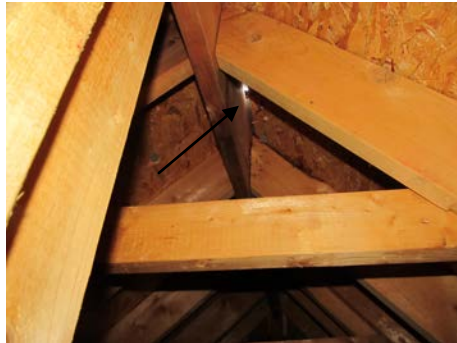
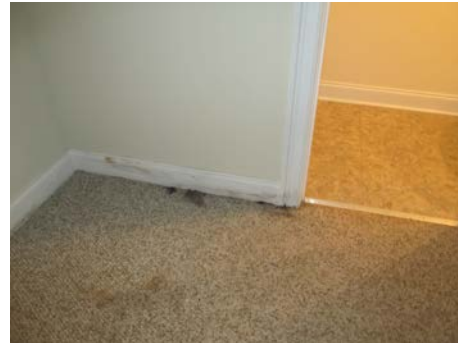
Roof leakage appears to have cause moisture damage and mold like substance in the upstairs front right bedroom.

**There appeared to be roof leakage at the ends of the ridge vents due to missing ridge end caps.**

There was evidence of roof leakage in these locations at the upstairs front right bedroom , recommend further evaluation by a licensed roofer.

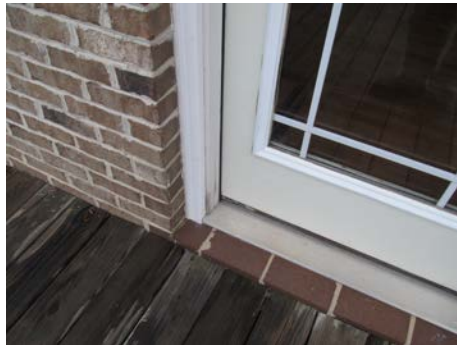
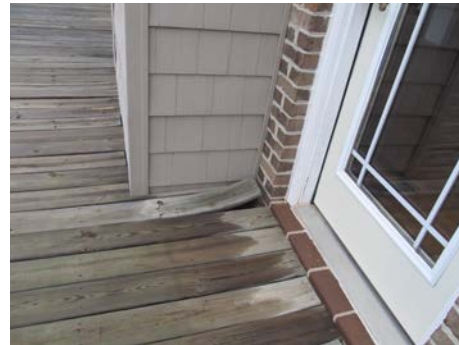
Recommend painting and caulking the exterior wood door frames.

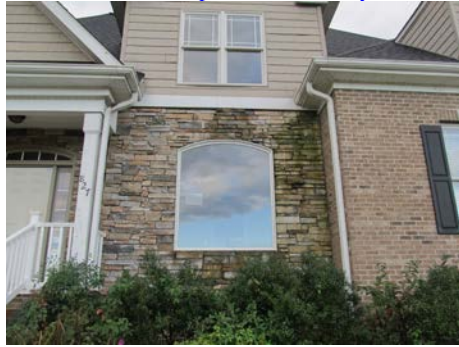
Specific problems noted with the visible components include, but may not be limited to: (list all that apply)

- Weep screeds are missing at the base of the wood frame walls.
- Weep screeds are missing at the tops of window and door openings.
- There is no caulk between other materials and the masonry veneer at windows, doors, and adjacent trim.
- The masonry veneer is in contact with the ground.
- Water entry in the stone and wall cavity.

The lack of proper detailing and flashing may result in water penetration behind the siding, resulting in structural damage. The installation of the manufactured stone veneer should be evaluated, compared to the specific installation requirements of the stone manufacturer and the MVMA, and repaired or replaced as deemed necessary by a licensed general contractor or masonry contractor experienced with installation requirements for manufactured stone veneer.

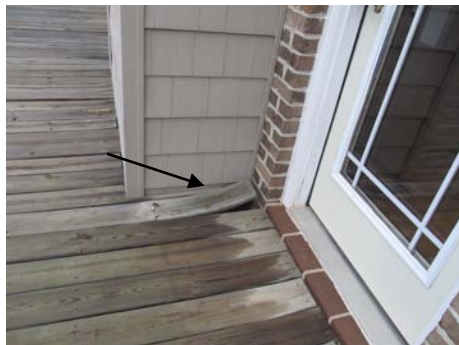
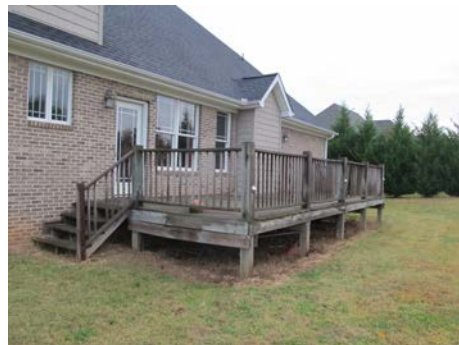
The rear deck had loose deck boards and step boards, recommend repair.

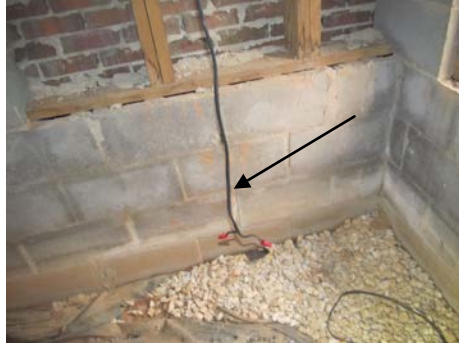
There was a wire end in the crawl space that should be installed in a covered junction or removed.

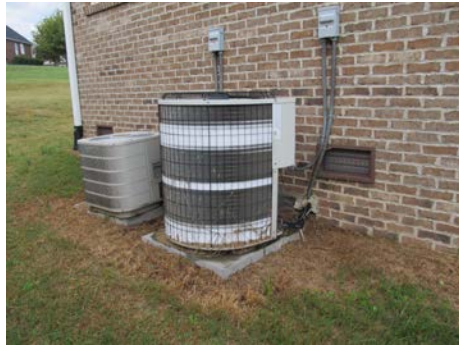
The condenser unit frosted on the heat cycle, recommend further evaluation and repair by a licensed HVAC contractor.

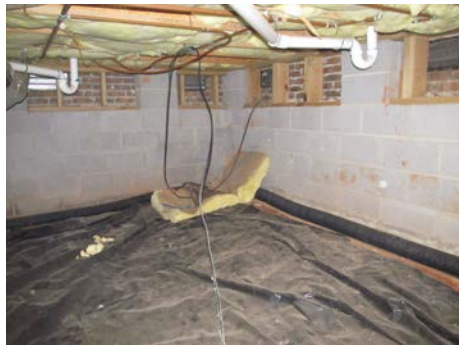
- **Repair:** Loose or damaged insulation in the floor above the crawl space should be improved.

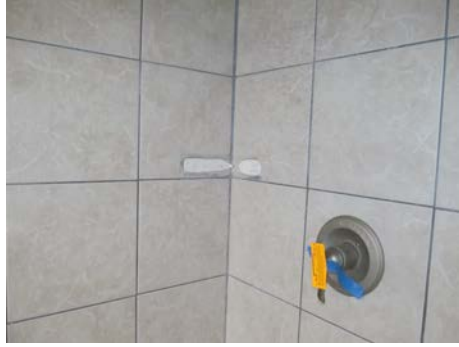
There was a caulked area in the master shower.

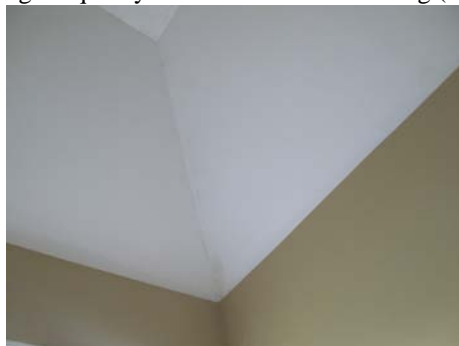
- **Monitor:** Water staining was noted.

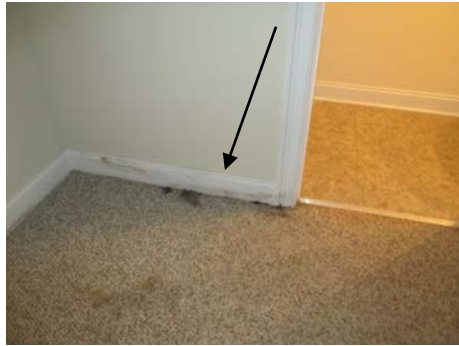
- 
- **Repair:** Water damage was noted in the dining room and upstairs front right bedroom.
- **Monitor:** Minor cracks were noted.
- **Monitor:** Larger than typical cracks were noted.
- **Monitor:** Signs of mildew were observed.

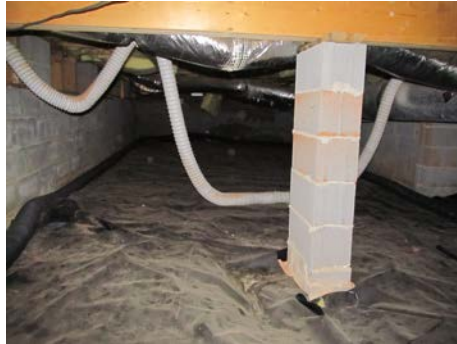
Recommend replacing the plastic dryer vent with a UL labeled dryer vent.
