Building Inspection Report

123 Easy St Greenville SC

Inspection Date:
11/11/11

Report Number:
201110291

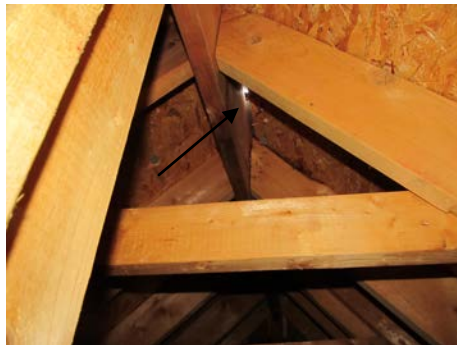
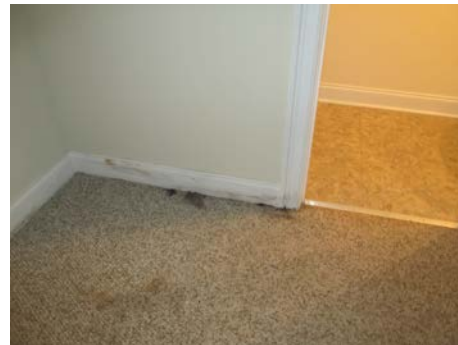
Roof leakage appears to have cause moisture damage and mold like substance in the upstairs front right bedroom.

There appeared to be roof leakage at the ends of the ridge vents due to missing ridge end caps.

There was evidence of roof leakage in these locations at the upstairs front right bedroom, recommend further evaluation by a licensed roofer.

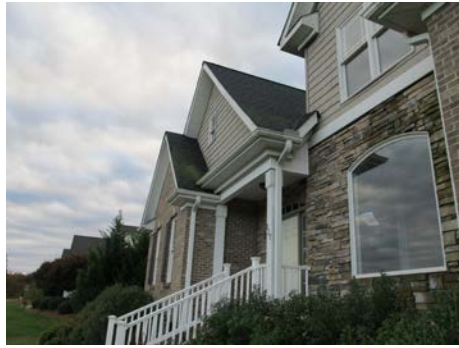
Sloped Roofing

- **Monitor:** The roofing is in fair condition. The roofing shows evidence of moss and organic build up in shaded areas. This condition may reduce the life expectancy of the roofing. Trimming or removing trees could improve this condition.

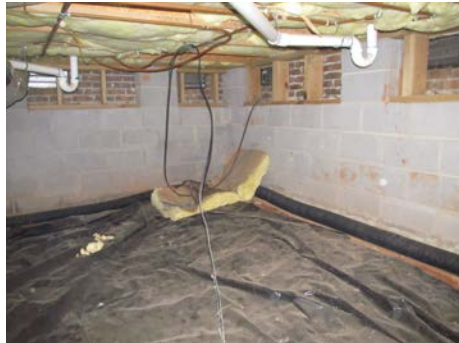
Crawl Space

- **Repair:** Loose or damaged insulation in the floor above the crawl space should be improved.

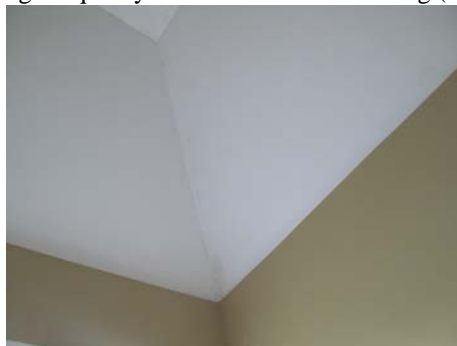
Wall / Ceiling Finishes

- **Monitor:** Water staining was noted.

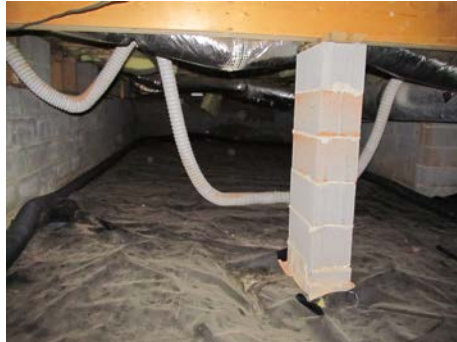
Recommend replacing the plastic dryer vent with a UL labeled dryer vent.
